STRENGTHENING OF BRICK INFILLED R/C FRAMES WITH CFRP REINFORCEMENT

G. Özcebe¹ and E. Akin²

ABSTRACT

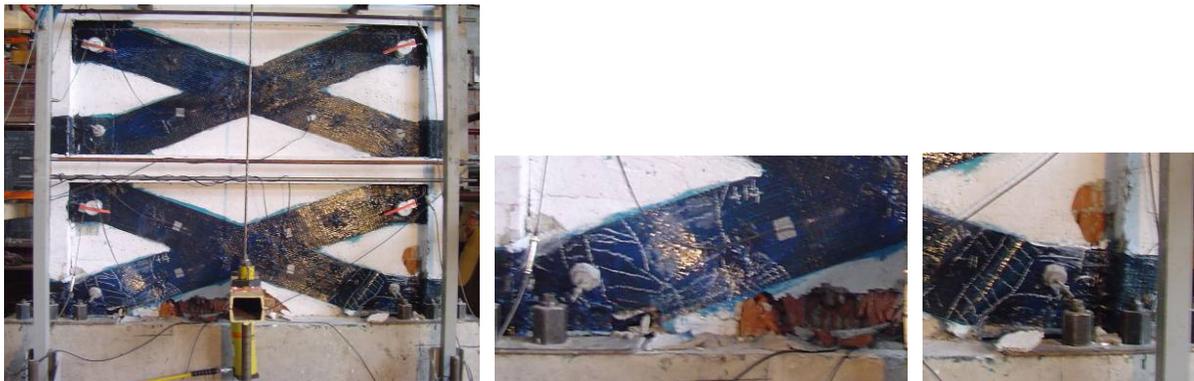
Figure 5. The specimen LSTR at the end of the test.

The idea of the FRP retrofit scheme was to reduce the inter-story deformation demands by using FRPs to act as tension ties similar to a steel cross-brace configuration. During the test, the first hairline cracks were observed in the 5th positive displacement cycle, at a load level of 70kN, at the intersection region of the first story infill wall and foundation. The first visible flexural crack developed at the column-footing interface at lateral load level of 80kN. The performance of the CFRP anchorages and cross overlay sheets was quite satisfactory under the applied cyclic lateral loads up until the ultimate load level of 120kN, which was reached at a lateral drift ratio of 0.5 percent. After this stage, especially during the large lateral deformation cycles, the diagonal CFRP sheets experiencing large compressive deformations started to debond at the corners of first story infill walls. During the consecutive half cycle, the CFRP strips in the debonded regions started to split, which ceased the beneficial contribution of the CFRP reinforcement on the frame response. The CFRP sheets, which were used as lateral reinforcement at the lapped splicing region of the first story columns, became ineffective upon crushing of the cover concrete, and this event marked the end of the test. Figure 5 shows specimen LSTR at the end of the test.

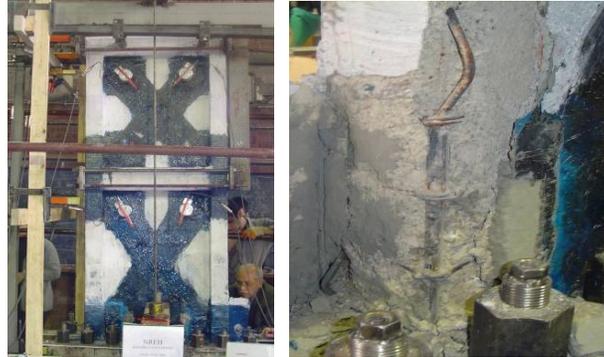
Figure 6. The specimen NREH at the end of the test.

was at the wall- frame interface. Similar to LSTR, debonding of CFRP was observed at an interstory drift ratio of 2.87 percent. Following this event, significant damage started to accumulate at the bottom ends of the first story columns. At the end of the test, the specimen displayed a flexural failure by the crushing of the core concrete and buckling of the longitudinal reinforcement at the bottom ends of the first columns. Figure 6 shows the specimen at the end of testing.
