Canadian Association for Earthquake Engineering and Seismology (CAEES) L'Association Canadienne du Génie Parasismique et de la Sismologie (ACGPS)

April 2024 Volume 8, Issue 2

## The February 2023 Earthquake Sequence in Turkey: Seismological Aspects

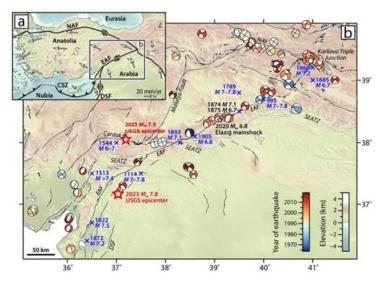
Inset: Tectonic summary of eastern Turkey. Main: 2023 Mw 7.8 and Mw 7.5 epicenters (red stars), instrumental EQs since 1960s (beach balls), historical EQs (blue Xs), and mapped active faults. Updated from: Pousse-Beltran et al. "The 2020 Mw 6.8 Elazığ (Turkey) earthquake reveals rupture behavior of the East Anatolian Fault." Geophysical Research Letters 47.13 (2020): e2020GL088136

which is moving westwards (see Figure). The EAF is therefore a counterpart of the more famous, rightlateral North Anatolian fault (NAF), the two faults working together to allow westward escape of Anatolia from the Arabia-Eurasia collision zone. However, whereas the NAF hosted the classic sequence of a dozen Mw 7-8 earthquakes during the past century—culminating in the damaging Izmit and Düzce earthquakes of 1999 east of Istanbul—the EAF had a considerably quieter instrumental record until the 2023 earthquakes. The eastern part of the EAF had seen the most action, with Mw 6.8 earthquakes in 2020 (Elazig) and 1971 (Bingöl). The western part of the fault, responsible for the 2023 Mw 7.8 earthquake, had not ruptured for far longer.
